**CITY OF LA VISTA  
MAYOR AND CITY COUNCIL REPORT  
FEBRUARY 7, 2012 AGENDA**

<b>Subject:</b>	<b>Type:</b>	<b>Submitted By:</b>
84 <sup>TH</sup> STREET BLIGHT AND SUBSTANDARD STUDY	◆ RESOLUTION ORDINANCE RECEIVE/FILE	ANN BIRCH COMMUNITY DEVELOPMENT DIRECTOR

# Blight/Substandard Determination Study "84<sup>TH</sup> Street Redevelopment Area"

La Vista, Nebraska

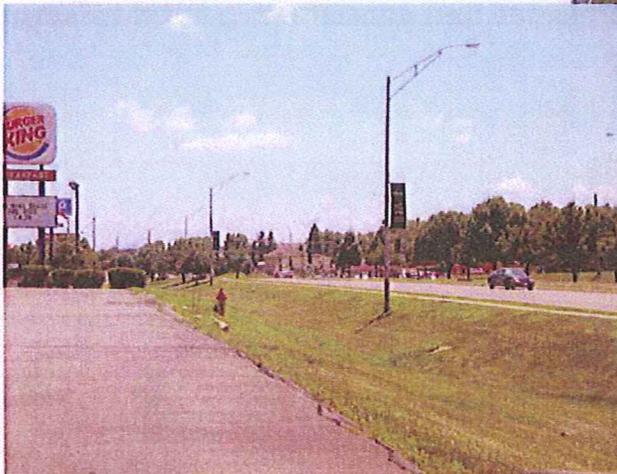
*No pedestrian sidewalks between businesses and 84<sup>th</sup> Street public sidewalk.*

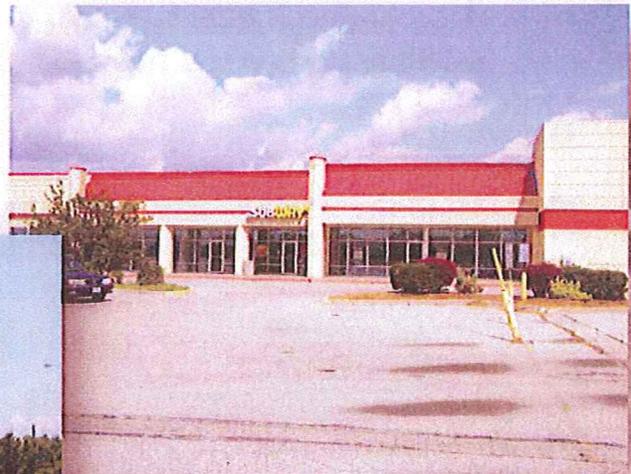
*Occupied storefront.*

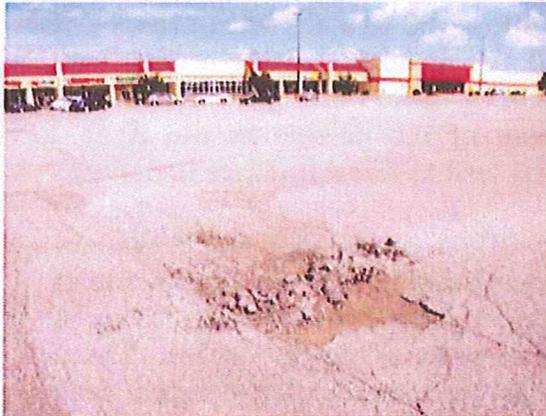
*Brentwood Plaza*

3. Parking lots throughout the **Redevelopment Area** lack designated pedestrian paths or sidewalks. If the parking lots would be fully occupied, pedestrians would need to walk up to a distance of approximately 300 to 400 feet from the rear of the lot to the front door of many retail establishments, through a deteriorated asphalt surfaced parking lot.

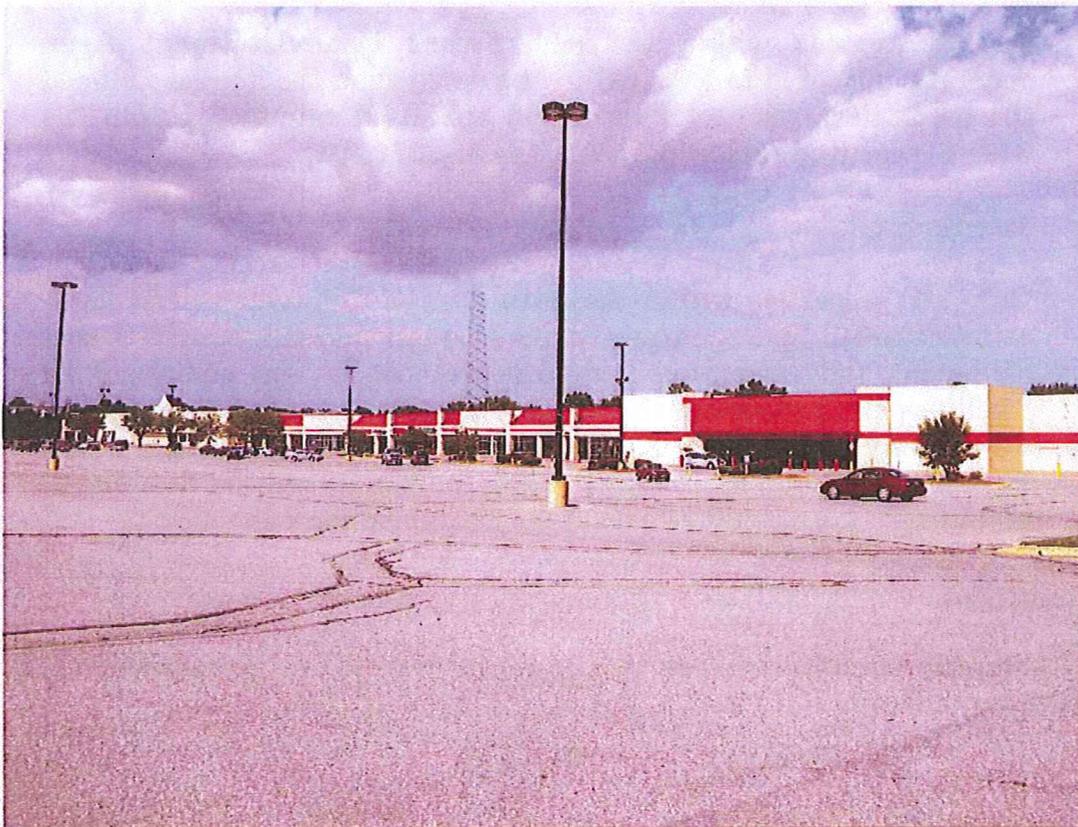
*Former Walmart shopping center.*

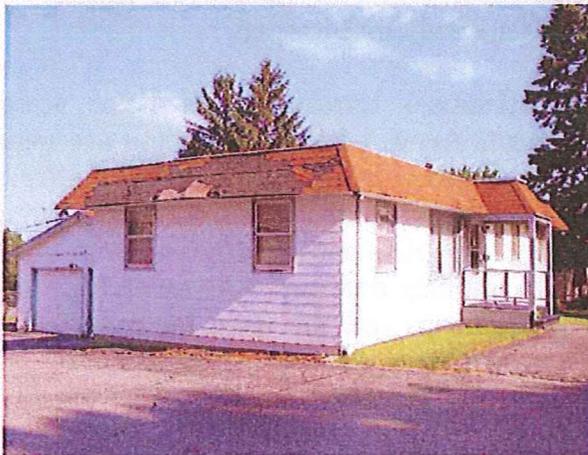
*Located at 7405 S. 85<sup>th</sup> St.*

The conditions which endanger life or property by fire and other causes are a strong presence throughout the 84<sup>th</sup> Street Redevelopment Area.

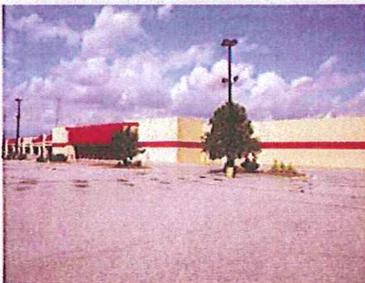
Former Walmart

Other Environmental, Blighted Factors are a strong presence throughout the 84<sup>th</sup> Street Redevelopment Area, containing a significant amount of functionally and economically obsolete commercial properties and a variety of undevelopable narrow width lots.

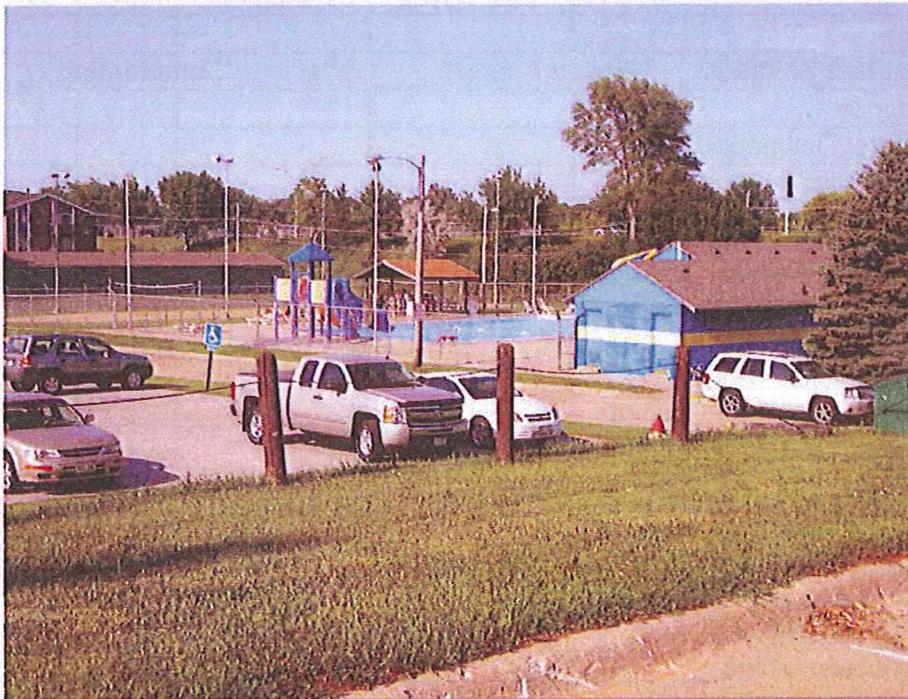
*The Municipal Pool and Kelly McMahon Park are located approximately 20 feet below the elevation of the 84<sup>th</sup> Street public sidewalk and the adjacent Shadow Ridge Apartments.*
