Subject:	Type:	Submitted By:
ROTELLA'S ITALIAN BAKERY – BLIGHT & SUBSTANDARD DETERMINATION STUDY	◆ RESOLUTION ORDINANCE RECEIVE/FILE	BRUCE FOUNTAIN COMMUNITY DEVELOPMENT DIRECTOR

Rotella's Italian Bakery Redevelopment Area.

Blight & Substandard Determination Study.

CONTEXT MAP – ILLUSTRATION 1

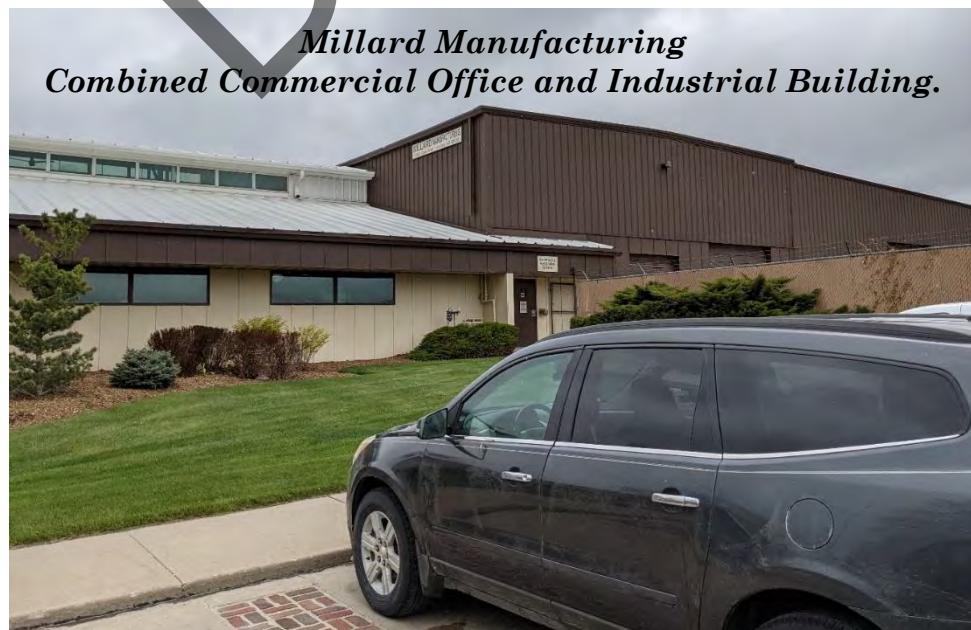
*Millard Manufacturing
Combined Commercial Office and Industrial Building.*

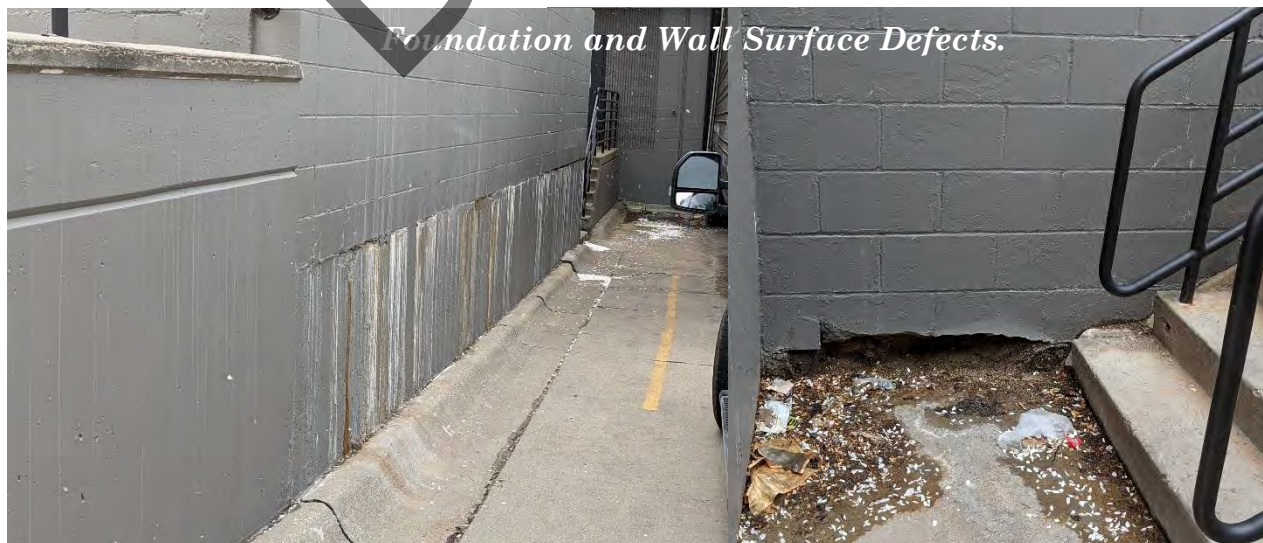
OVERALL STRUCTURE CONDITIONS MAP – ILLUSTRATION 4

The results of the **Structural/Site Conditions Survey** identified **seven structures** in the **Rotella’s Italian Bakery Redevelopment Area** as being in a **deteriorating** condition with minor defects and **one structure** as being in a **deteriorating** condition with major defects. Thus, **all of the eight total structures** are in a **deteriorating** condition with minor defects or worse. This **Factor** is a **reasonable presence** throughout the **Area**.

The results of the **Structural/Site Conditions Survey** indicate deteriorating structures are a reasonable presence throughout **Rotella's Italian Bakery Redevelopment Area**.

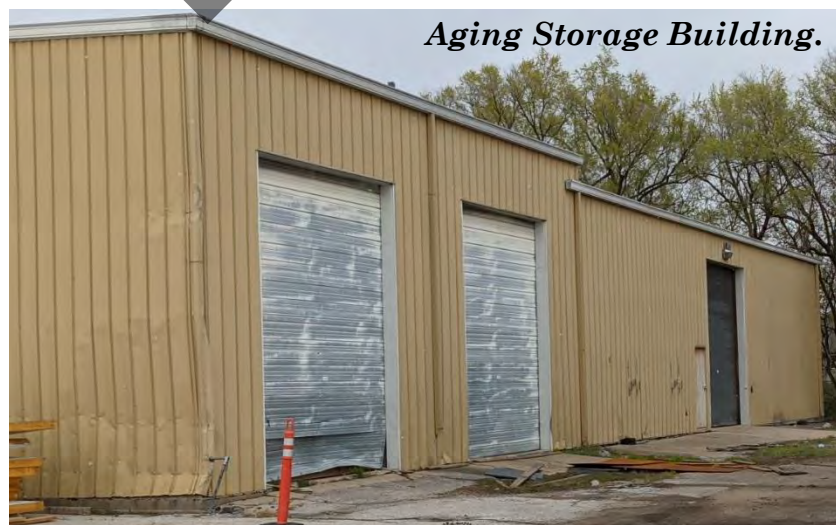
AGE OF STRUCTURES MAP – ILLUSTRATION 5

The age and obsolescence of structures is a strong presence throughout the Rotella's Italian Bakery Redevelopment Area.

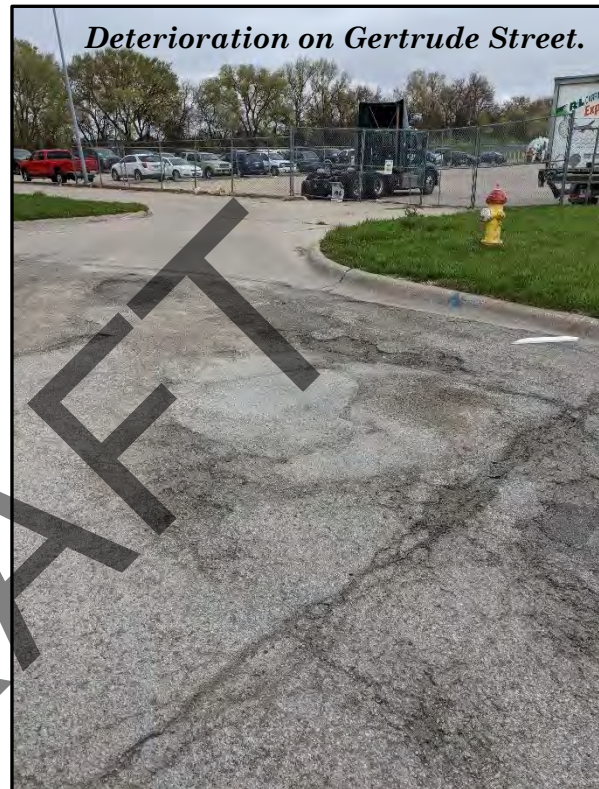
Street conditions within the **Redevelopment Area** were, generally, found to be in "good" or "fair" condition. Of the eight total parcels, four (50 percent) were found to have "fair" street conditions. Seven structures had parking surfaces rated deteriorated to a minor extent, or worse. The installation of modern infrastructure and utility systems may be required to attract new development and support redevelopment opportunities throughout the **Redevelopment Area**. **Illustration 7, Page 32**, identifies **Street Conditions** in the **Redevelopment Area**.

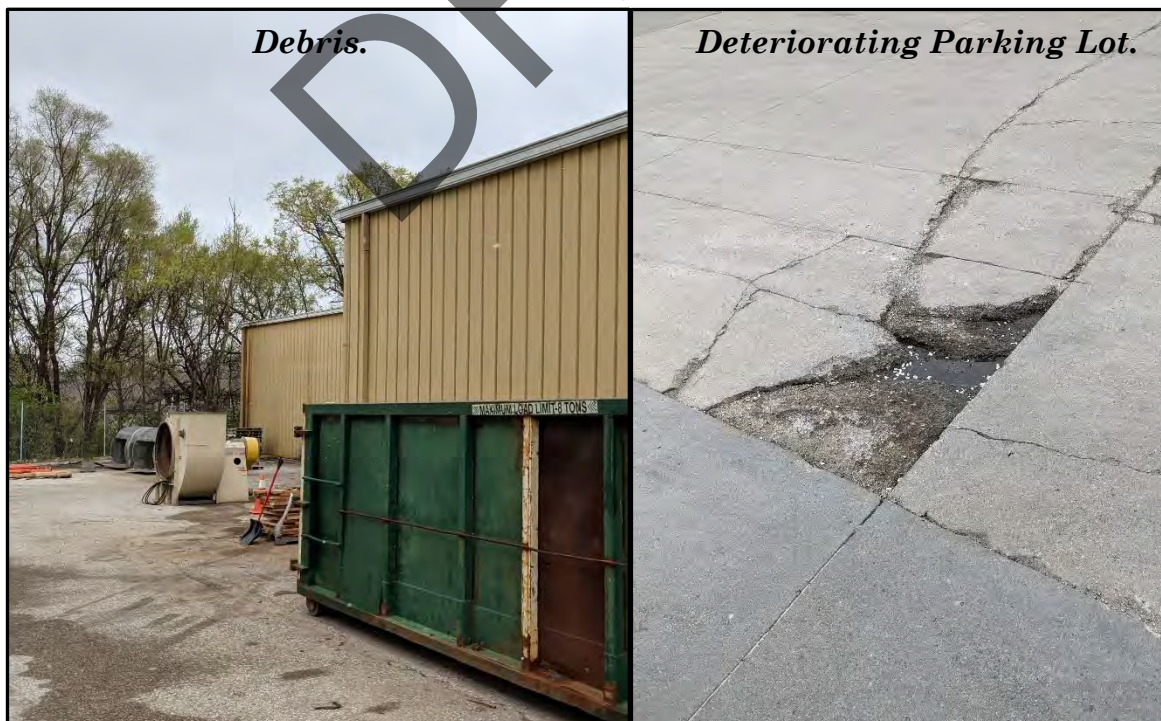
Deterioration of site improvements is a reasonable presence in the Rotella's Italian Bakery Redevelopment Area.

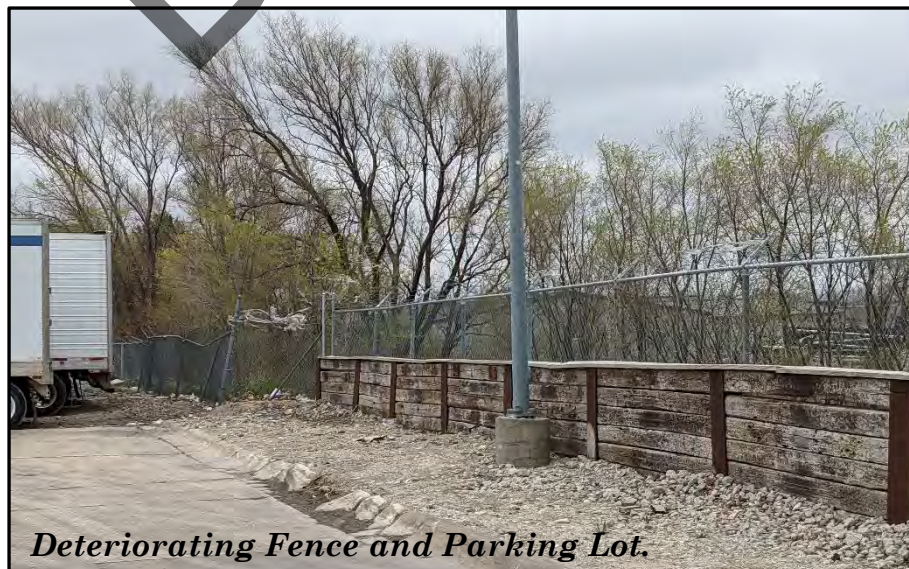
Other Environmental Blighting Factors are a reasonable presence throughout the **Rotella's Italian Bakery Redevelopment Area**, containing functionally and economically obsolete parcels.

Deteriorating Fence and Parking Lot.
