**CITY OF LA VISTA  
MAYOR AND CITY COUNCIL REPORT  
FEBRUARY 7, 2012 AGENDA**

<b>Subject:</b>	<b>Type:</b>	<b>Submitted By:</b>
84 <sup>TH</sup> STREET BLIGHT AND SUBSTANDARD STUDY	◆ RESOLUTION ORDINANCE RECEIVE/FILE	ANN BIRCH COMMUNITY DEVELOPMENT DIRECTOR

# Blight/Substandard Determination Study "84<sup>TH</sup> Street Redevelopment Area"

La Vista, Nebraska

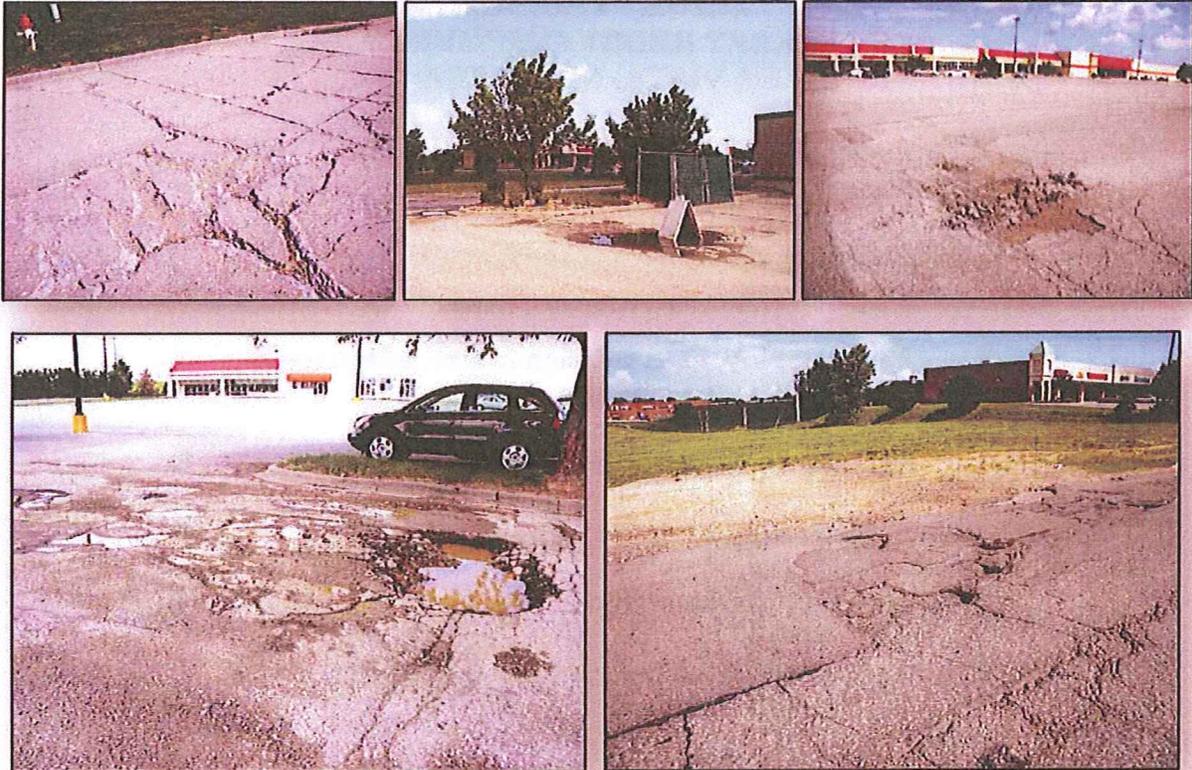
***Defective or Inadequate Street Layout*** is a strong presence in the 84<sup>th</sup> Street Redevelopment Area due to a significant percentage of privately owned and maintained “frontage” streets that are significantly deteriorated. Large areas are impacted by “alligator cracking” and settling, as well as several potholes within street rights-of-way and in private parking lots. Many of these potholes are large enough to damage motor vehicles. Additional frontage street sections lack concrete curbs, gutters and storm water drainage systems.

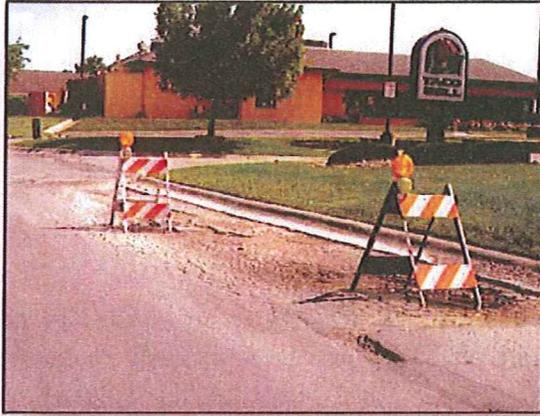
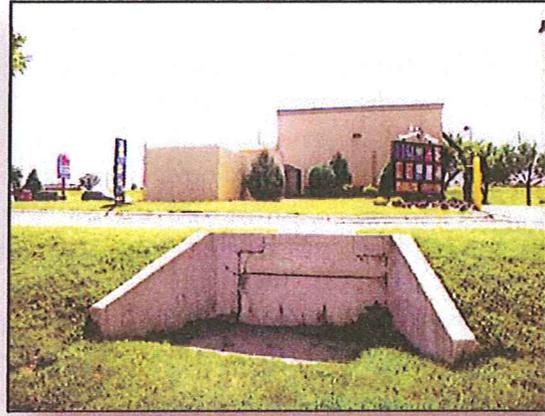
***Insanitary or Unsafe Conditions*** are a strong presence throughout the entire the 84<sup>th</sup> Street Redevelopment Area. Conditions contributing to this Factor include poorly designed and implemented, privately owned, storm water surface drainage systems and the advanced age of privately owned and maintained underground water, sewer and storm sewer mains in the Redevelopment Area.

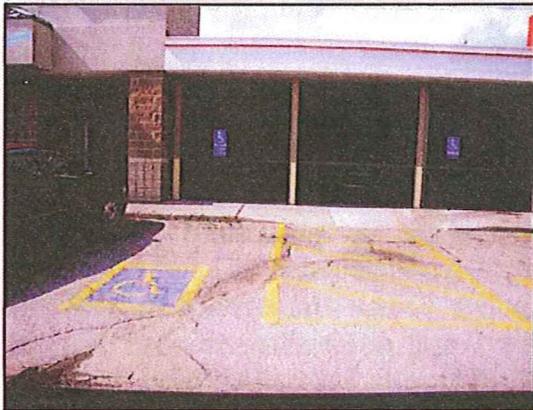
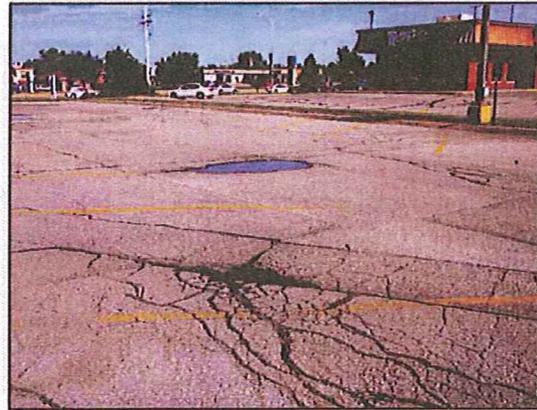
***Deterioration of Site or Other Improvements*** is a strong presence throughout the Area, where, of the total 63 parcels examined, 44.4 percent, or 28 parcels have “fair” to “poor” overall site conditions.

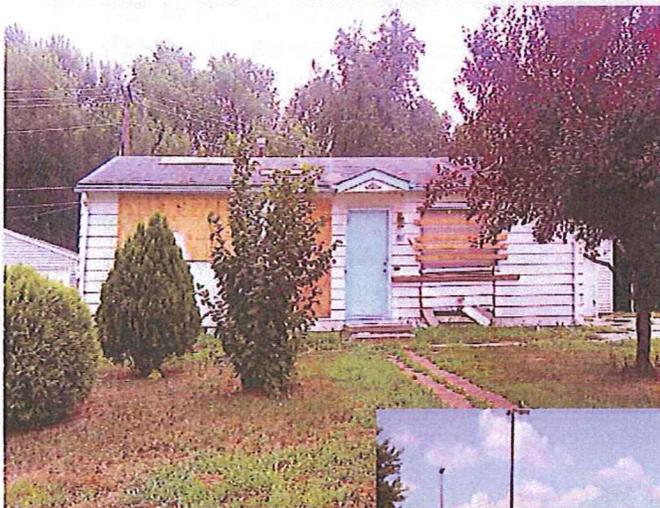
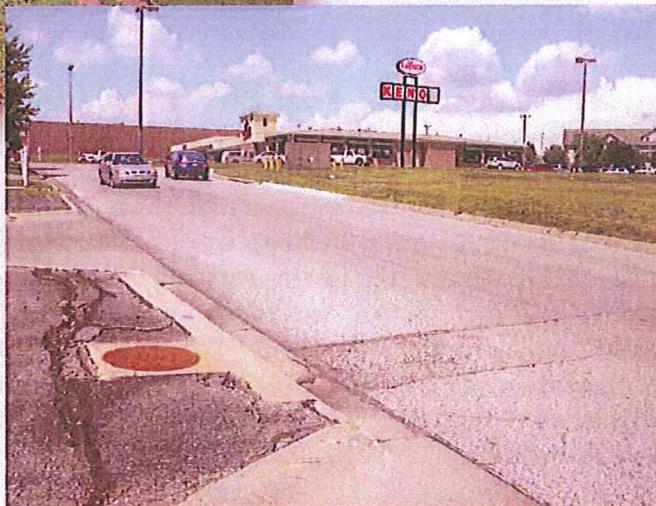
**The conditions which endanger life or property by fire and other causes are a strong presence throughout the 84<sup>th</sup> Street Redevelopment Area.**

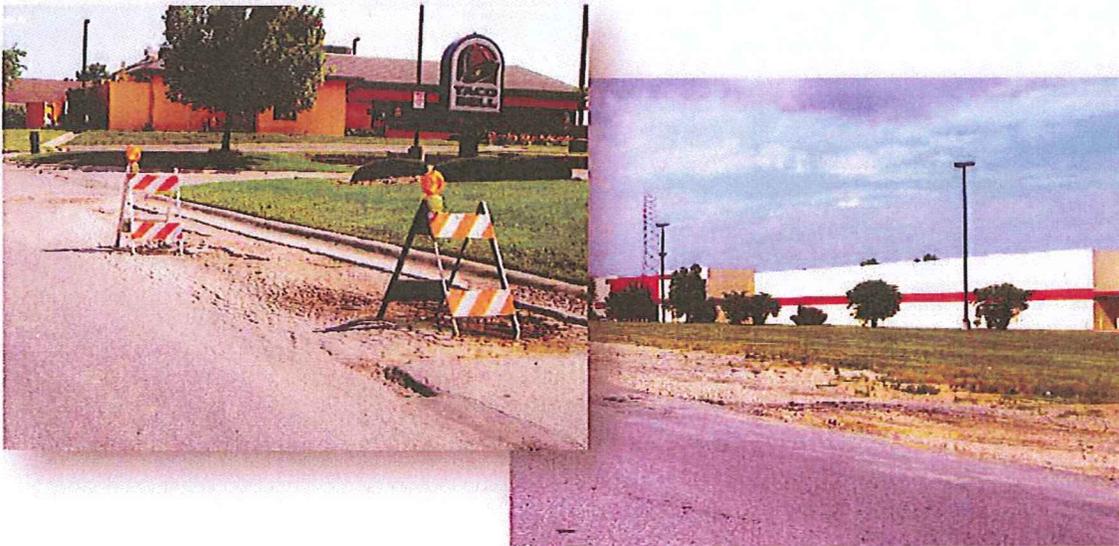
The existence of defective or inadequate street layout in the 84<sup>th</sup> Street Redevelopment Area is a strong presence and constitutes a Blight Factor.

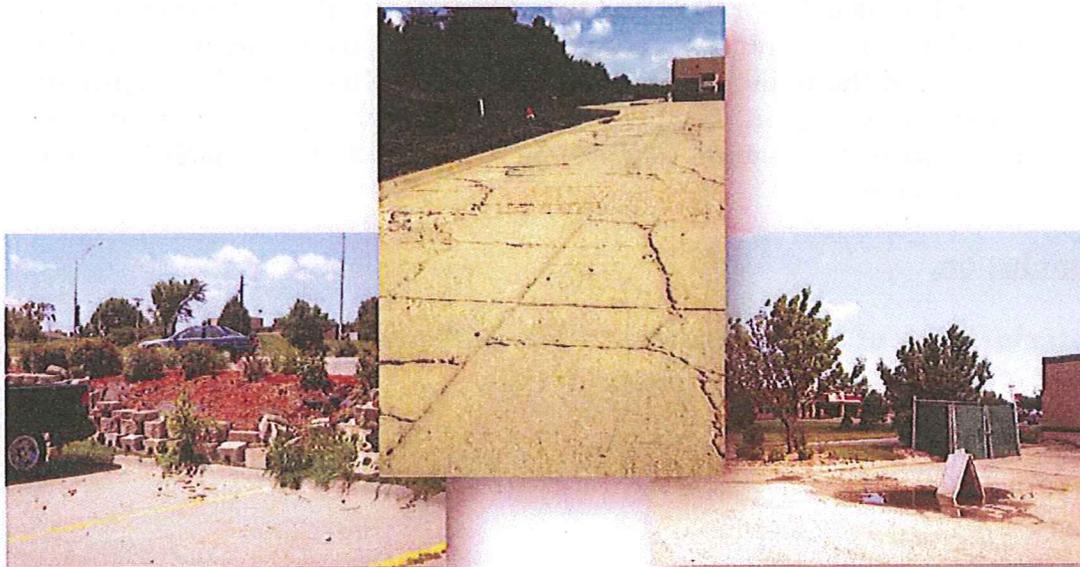
1. Many buildings and/or shopping facilities throughout the Area are accessed by asphalt or concrete surfaced streets. Several segments of privately owned “frontage streets” were observed to lack concrete curbs and gutters and thus have open storm water drainage ditches. These frontage roads were also observed to be severely deteriorated with large areas impacted by cracking and settling. Many of these street segments also have several potholes, some that are large enough to damage vehicles to the extent that they are barricaded to divert traffic. As a result, these roads can become impassable during inclement weather. Ponding water in the areas with settling, potholes and storm water drainage ditches can attract mosquitoes and other pests.
