**CITY OF LA VISTA**  
**MAYOR AND CITY COUNCIL REPORT**  
**AUGUST 3, 2021 AGENDA**

<b>Subject:</b>	<b>Type:</b>	<b>Submitted By:</b>
ROTELLA'S ITALIAN BAKERY BLIGHT & SUBSTANDARD DECLARATION	◆ RESOLUTION ORDINANCE RECEIVE/FILE	BRUCE FOUNTAIN COMMUNITY DEVELOPMENT DIRECTOR

Blight & Substandard Determination Study.

## ROTELLA'S ITALIAN BAKERY REDEVELOPMENT AREA LA VISTA, NEBRASKA

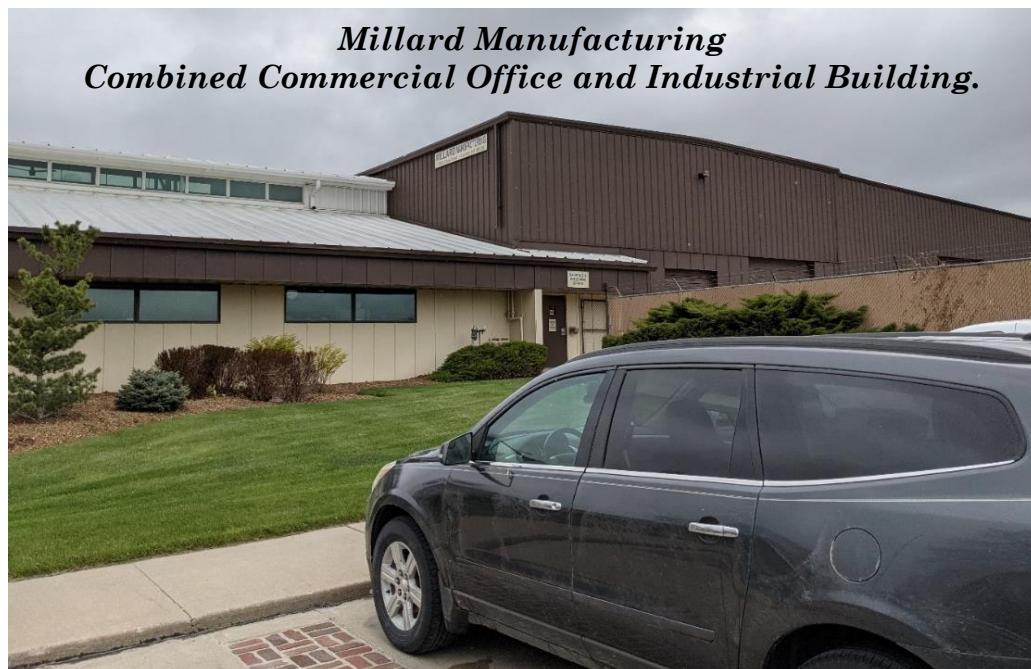
# EXISTING LAND USE MAP – ILLUSTRATION 2

**Table 3** identifies the estimated **Existing Land Use** within **Redevelopment Area**, in terms of number of acres and percentage of total for all existing uses. A map of **Existing Land Use** is also presented in **Illustration 2, Page 14**.

Industrial land uses comprise approximately 55.9 acres or 83.4 percent of the total land use in the **Redevelopment Area**. Millard Manufacturing is an industrial building with on-site offices. The Rotella's Italian Bakery Facility includes a combined office, industrial bakery and retail store within one connected structure. Portal Cemetery includes less than an acre of land and comprises approximately 1.2 percent of the total land area. Streets and public right-of-ways comprise approximately 10.3 acres or 15.4 percent of the **Redevelopment Area**.

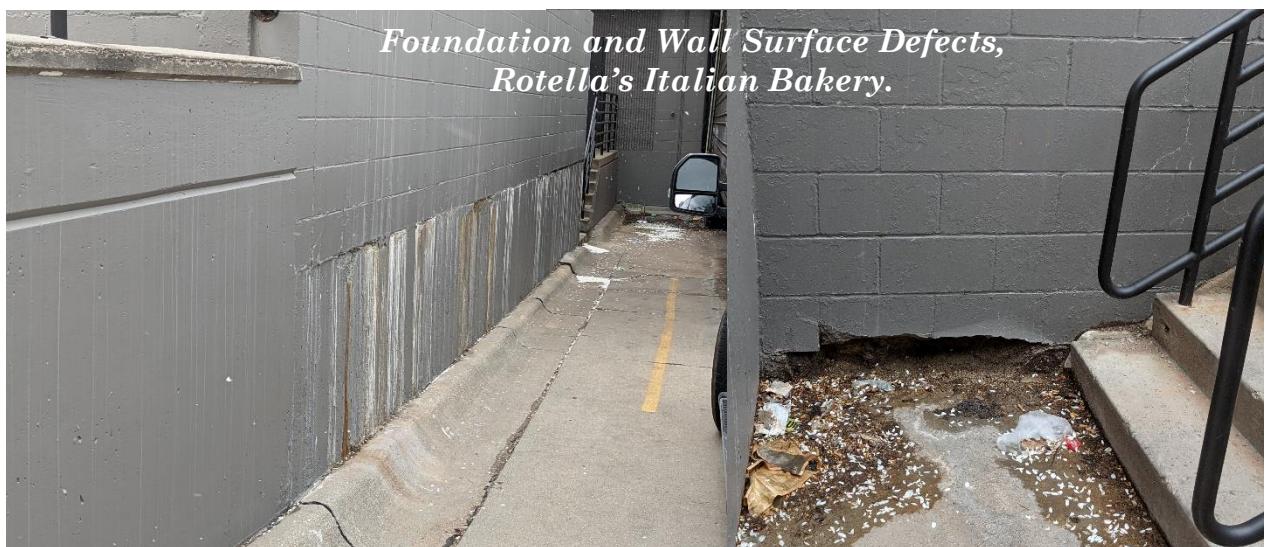
**OVERALL STRUCTURE CONDITIONS MAP – ILLUSTRATION 4**  
**ROTELLA'S ITALIAN BAKERY REDEVELOPMENT AREA**  
**LA VISTA, NEBRASKA**

**The results of the Structural/Site Conditions Survey indicate deteriorating structures are a reasonable presence throughout Rotella's Italian Bakery Redevelopment Area.**

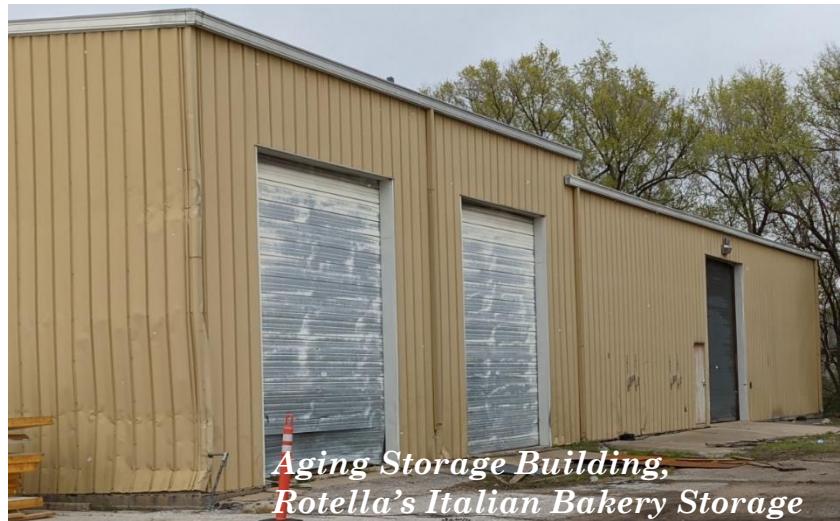
**AGE OF STRUCTURES MAP – ILLUSTRATION 5**  
**ROTELLA'S ITALIAN BAKERY REDEVELOPMENT AREA**  
**LA VISTA, NEBRASKA**

**The age and obsolescence of structures is a strong presence throughout the Rotella's Italian Bakery Redevelopment Area.**

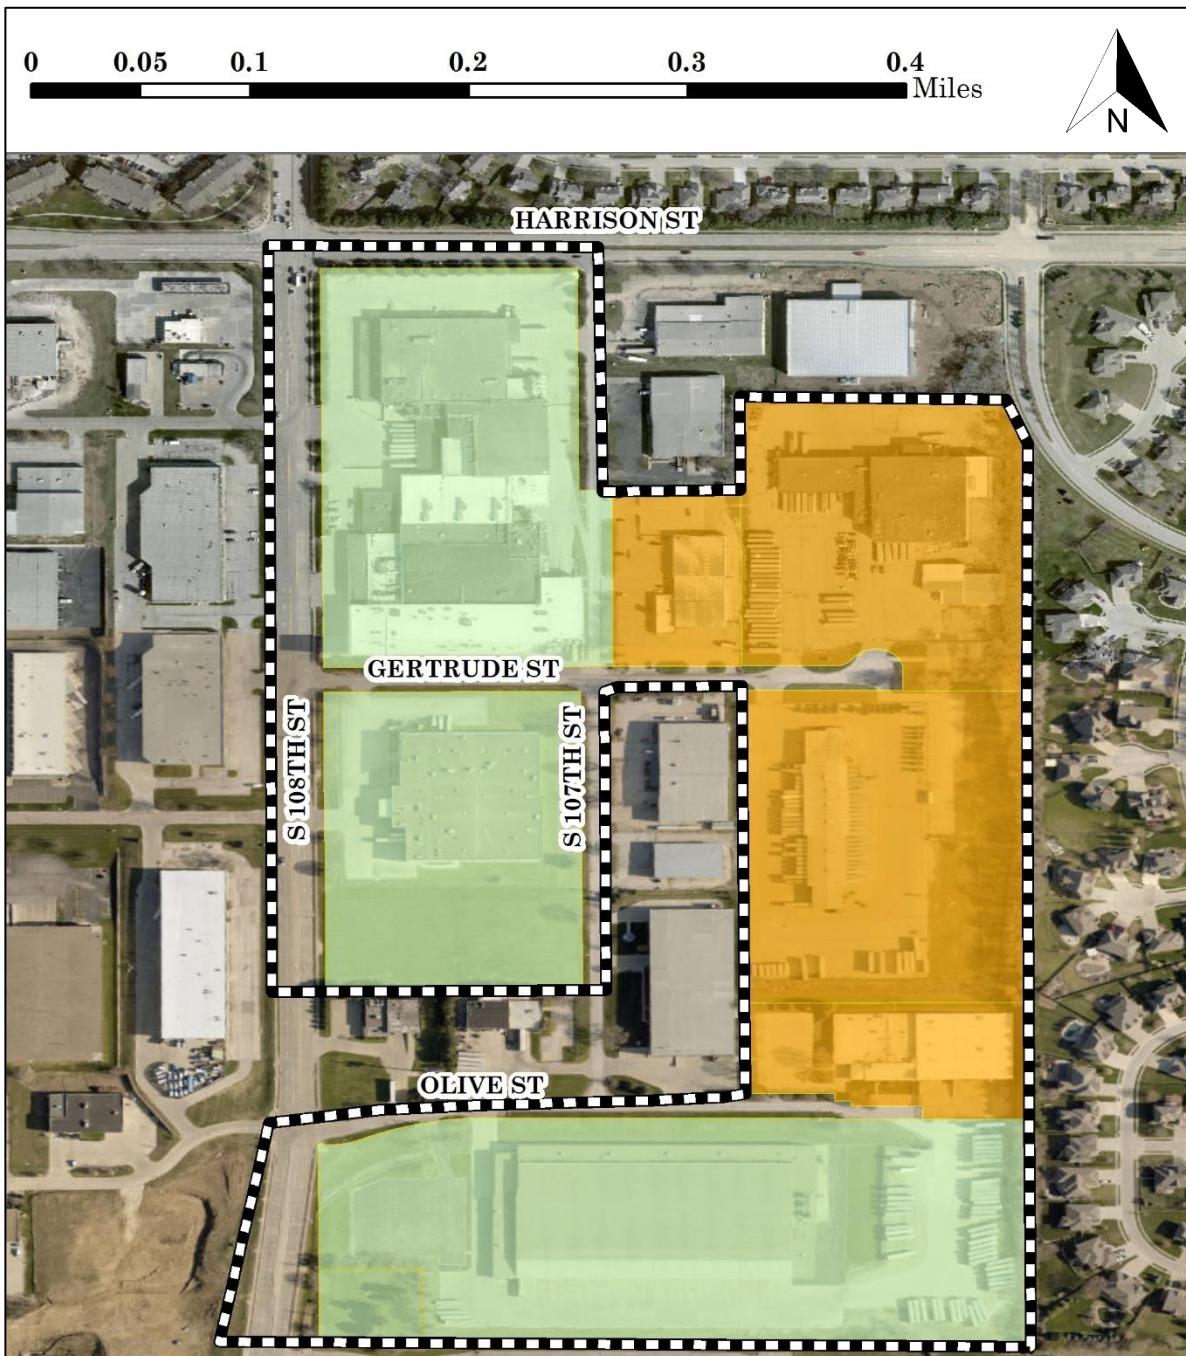
**STREET CONDITIONS MAP – ILLUSTRATION 7**  
**ROTELLA'S ITALIAN BAKERY REDEVELOPMENT AREA**  
**LA VISTA, NEBRASKA**

Street conditions within the **Redevelopment Area** were, generally, found to be in "good" or "fair" condition. This includes five public streets. Of the eight total parcels, four (50 percent) were found to front streets in "fair" condition. Seven of the parcels had parking surfaces rated deteriorated to a minor extent, or worse. The installation of modern infrastructure and utility systems may be required to attract new development and support redevelopment opportunities throughout the **Redevelopment Area**. **Illustration 7, Page 32,** identifies **Street Conditions** in the **Redevelopment Area**.

The existence of defective or inadequate street layout is a strong presence in the **Rotella's Italian Bakery Redevelopment Area**.
